2/8/2016

RAILWAY/NORTH ST ROUNDABOUT STUDY

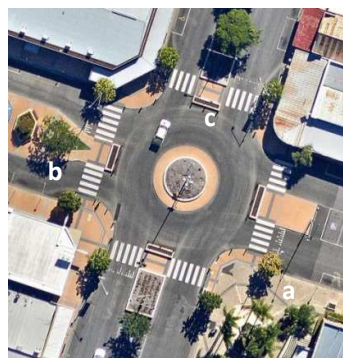
Results from the analysis indicated that:

- a. LOS east pedestrian crossing – A
Pedestrian facility prioritisation score - 1
- b. LOS west pedestrian crossing – A
Pedestrian facility prioritisation score - 5
- c. LOS north pedestrian crossing – A
Pedestrian facility prioritisation score - 2
- d. LOS south pedestrian crossing – B
Pedestrian facility prioritisation score - 3

All four legs provide excellent crossing opportunities as the LOS scores range from A to B and the Pedestrian facility prioritisation score is lesser than 6. Please refer to TORUM Volume 1 Part 6 for more detail.
