28/06/2016

TYLER STREET PEDESTRIAN CROSSING

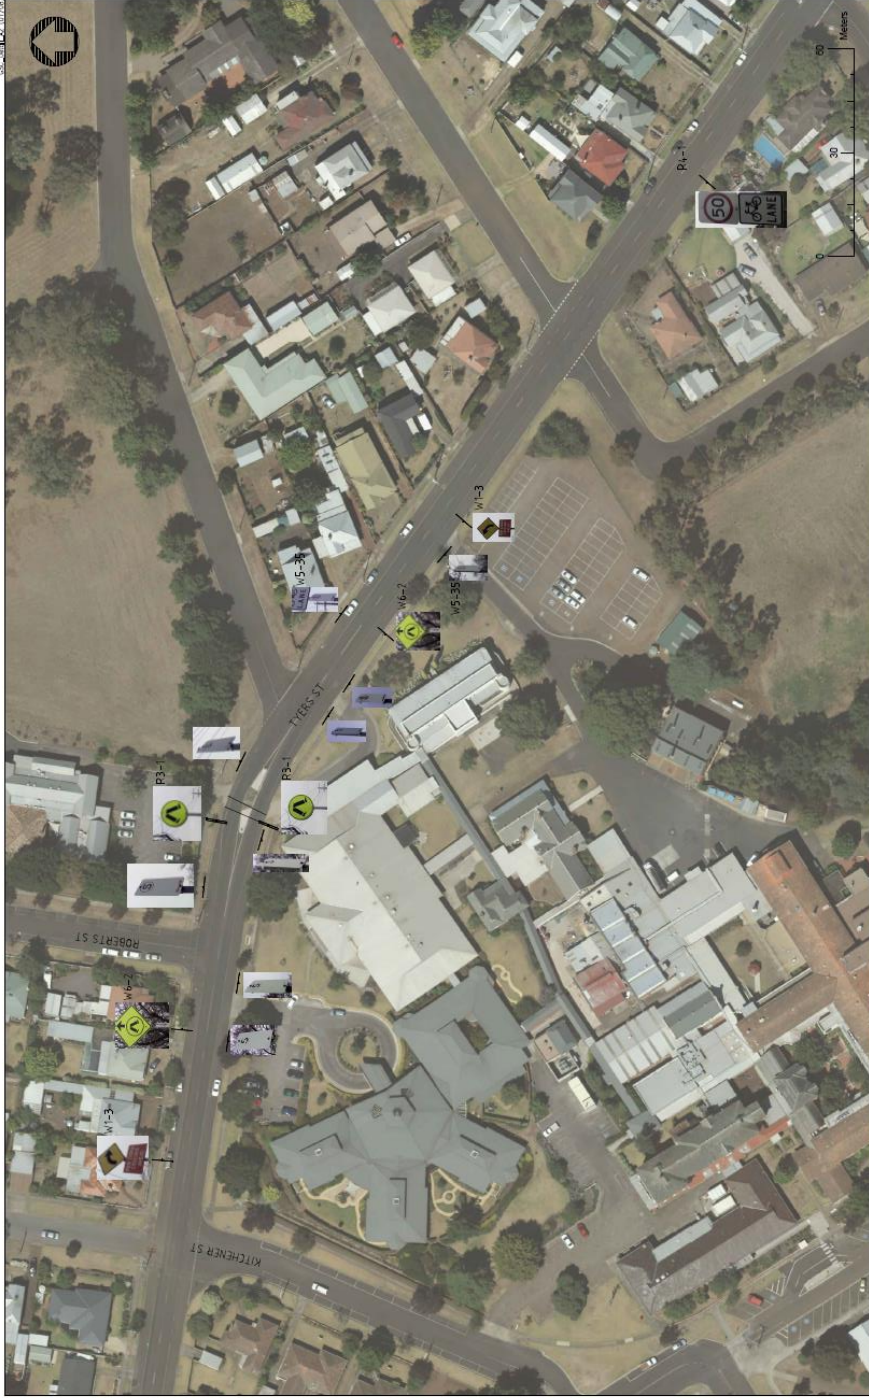
Drawing No. 1

Type of signs and location are shown in Appendix 1. The signage installed are in accordance to AS1742.10.

PEDESTRIAN CROSSING TYERS ST REPORTING
